Summary and Conclusion

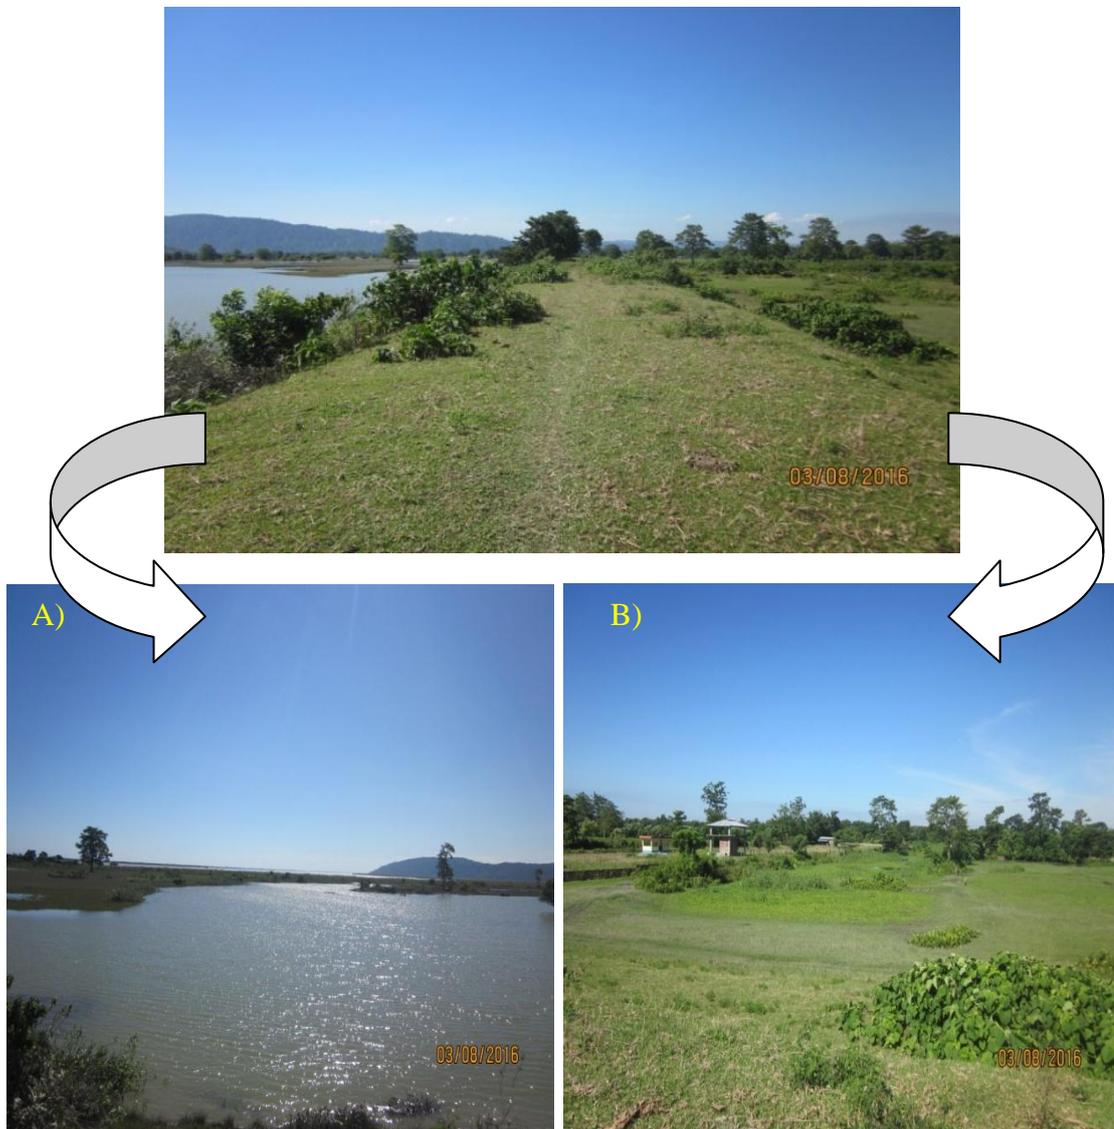
Plate 7.1 The Hatimura dyke showing its A) Brahmaputra side B) Kolong side

Since flood control was the main objective behind the construction of the Hatimura dyke, hence, the flow release plan should go in close association with proper measures keeping in mind the possibility of some high flow situations. Hence, the possible water surface elevations at two different magnitudes of flood viz. 25 year design flood and 100 year design flood were modeled using the HEC-RAS software. The water surface elevation values thus obtained for the entire river channel will be

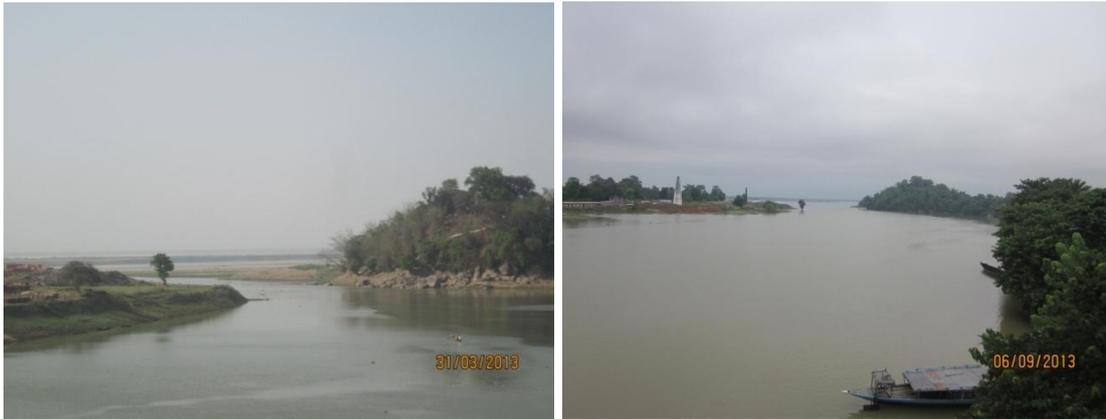
Plate 7.5 Kolong River at Kajalimukh during a) Pre-monsoon b) Monsoon

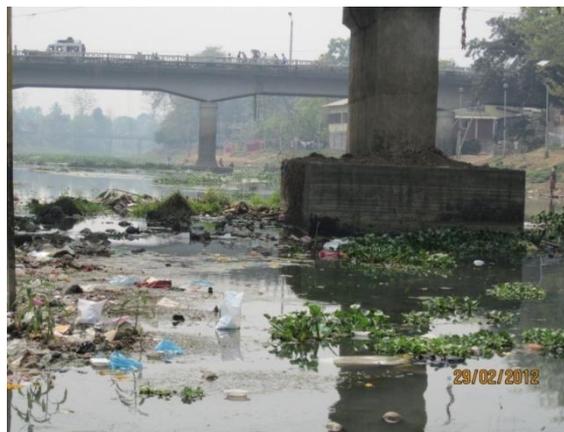
Plate 7.7 Solid waste dumped on Kolong River near Nagaon Town
