Chapter- IX

CHANNEL MIGRATION AND ITS IMPACT ON WILDLIFE HABITAT

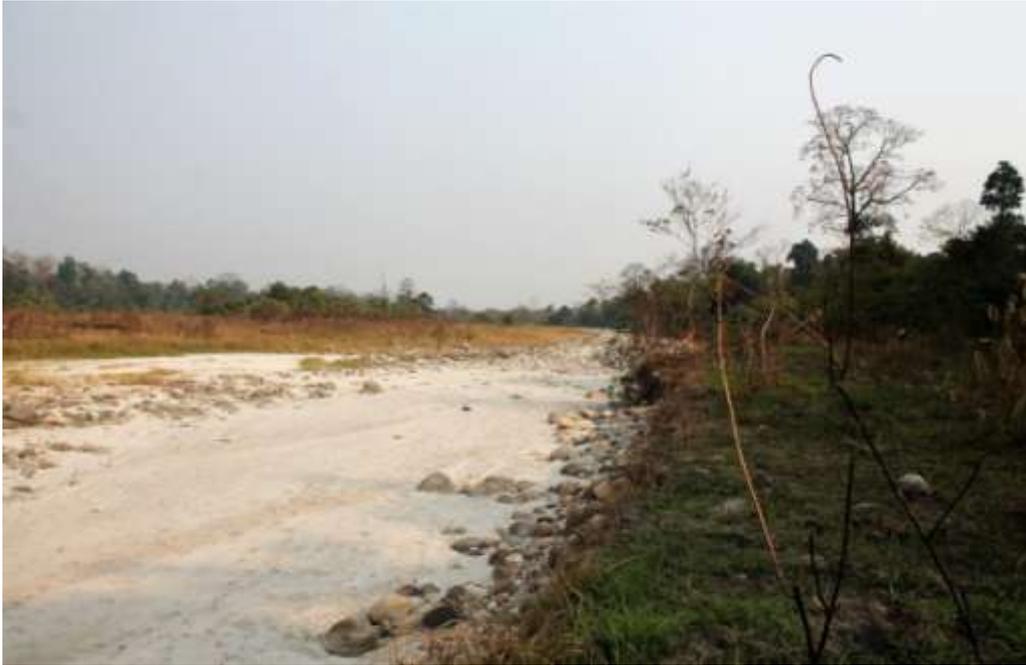
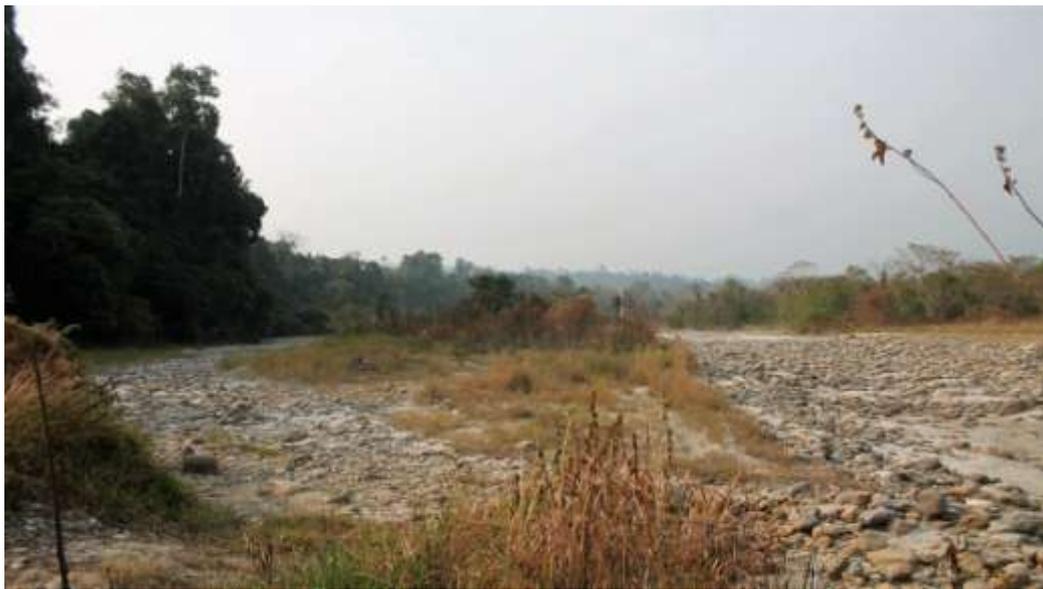
Plate: 9.1 (a & b): Showing Abandoned Channel of River Gelgeli

River Channel Migration for different years is shown in *Fig.9.10*, *Fig.9.11* and *Fig.9.12*. Channel migration is also responsible for creating abandoned channels which were used to serve as a wildlife habitat. This has resulted in habitat loss in the study area. Plate 9.1 shows abandoned channel of River Gelgeli. The abandoned channel has only sand and gravels which affects the vegetation growth. The growth of vegetation on theses abandoned channel is not occurring.

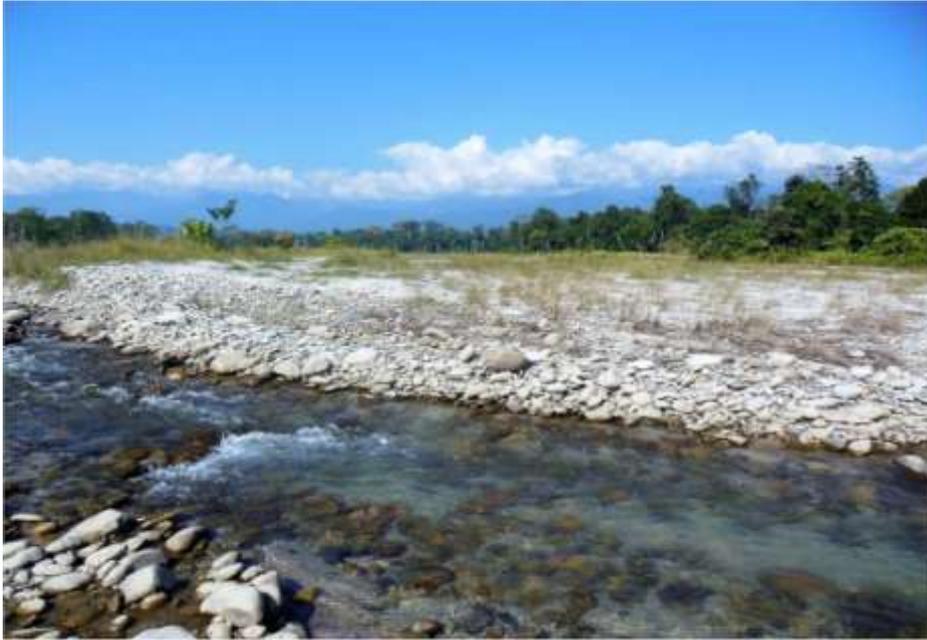
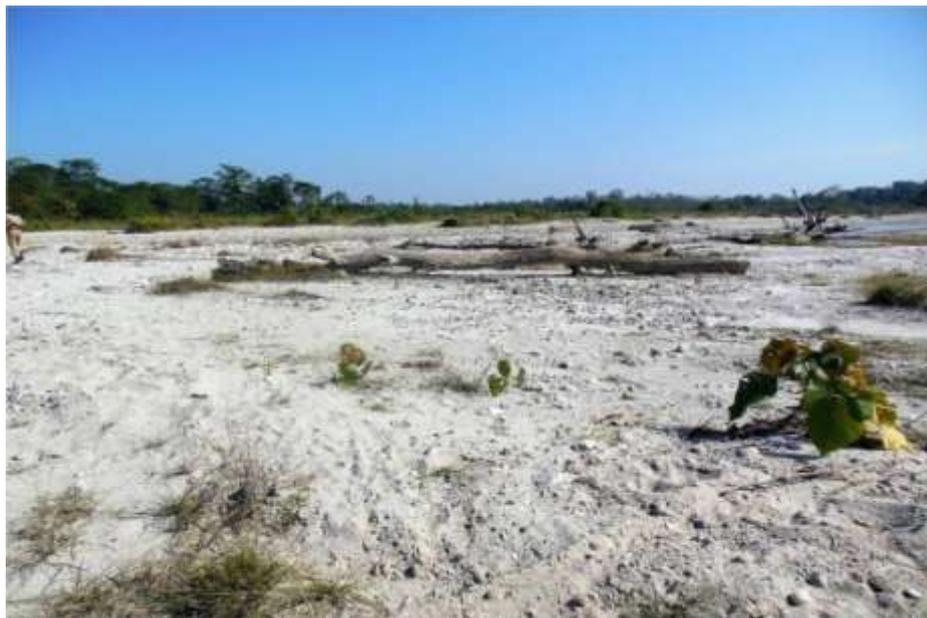
Plate 9.2 (a) & (b): Showing Sedimentation due to River Gelgeli

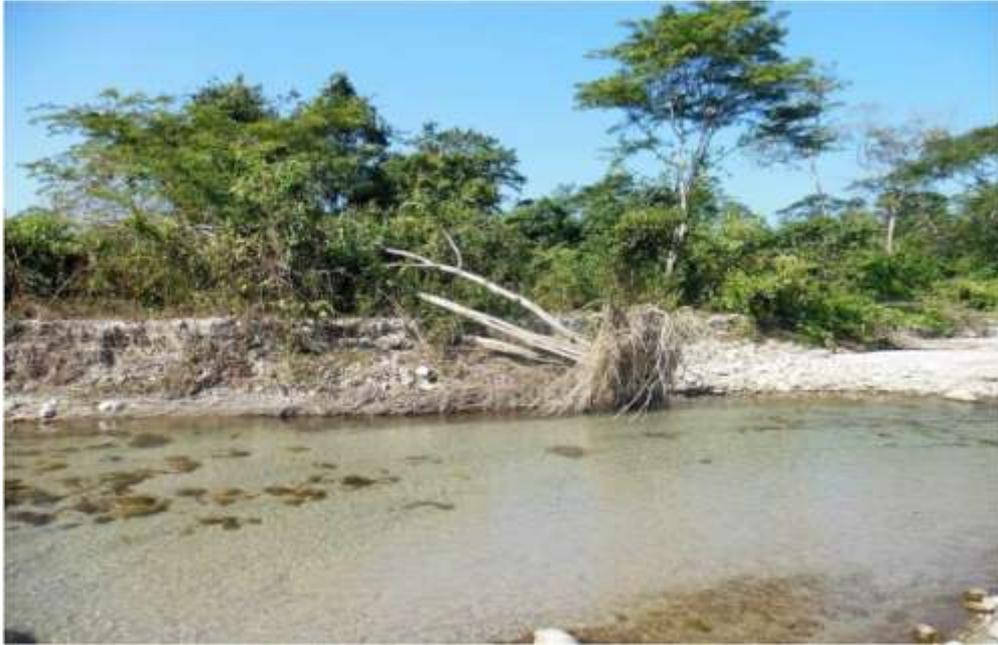
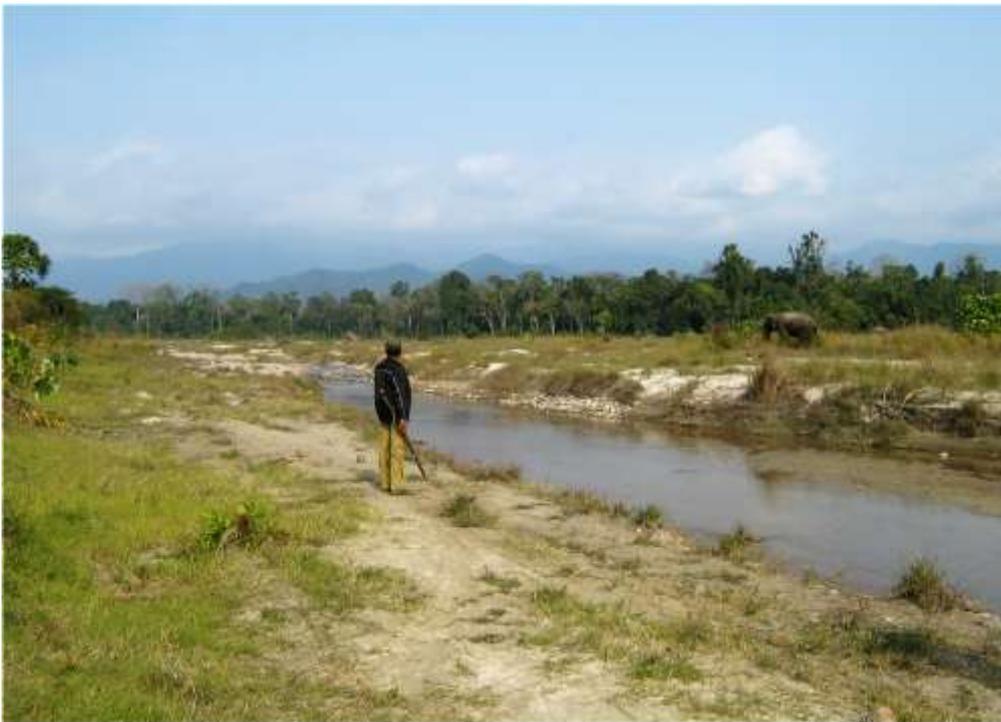
Plate 9.3 (a & b): Showing Forest loss and erosion near River Gelgeli

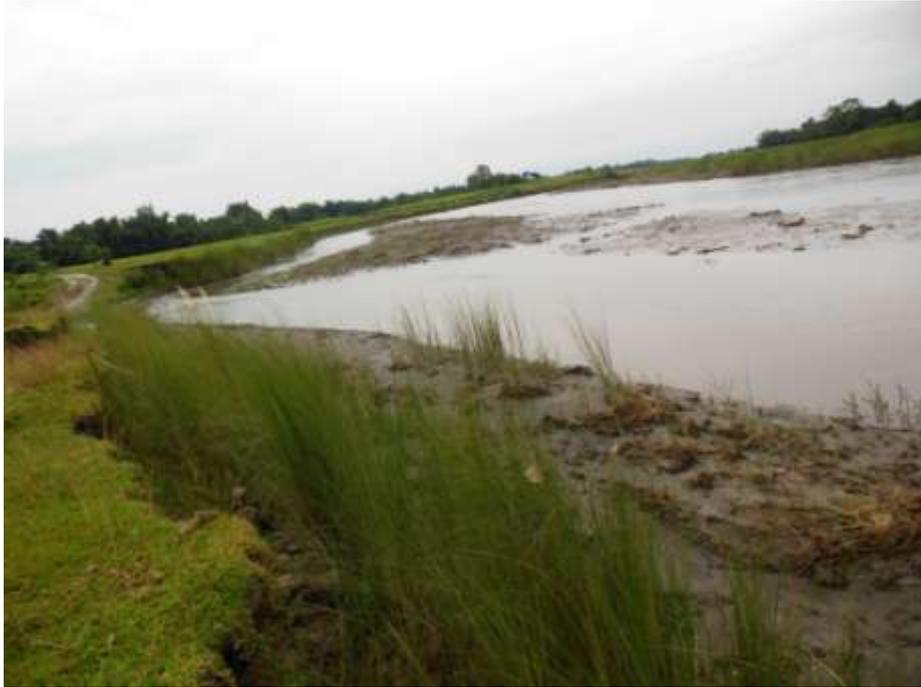
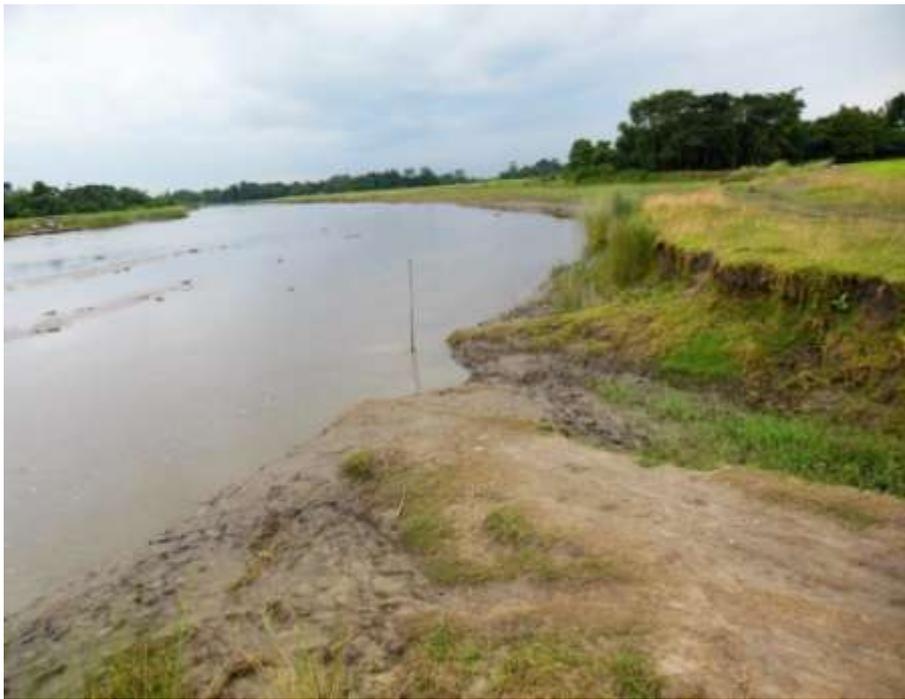
Plate 9.4 (a & b): Showing Forest loss near River Belseri

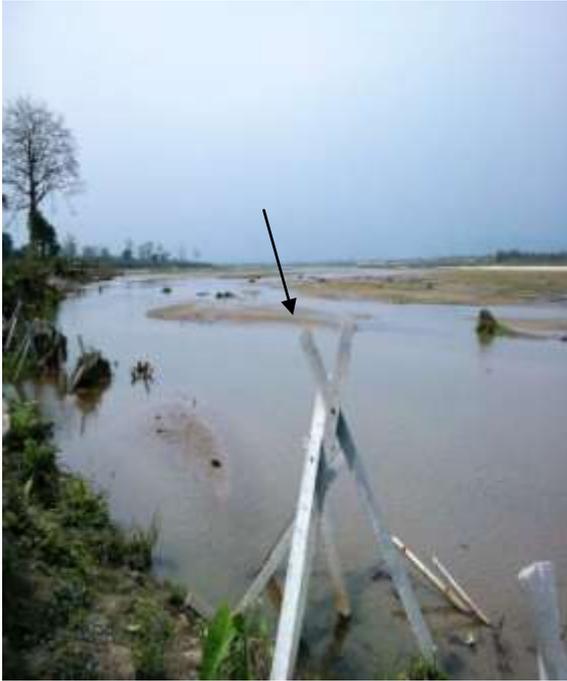
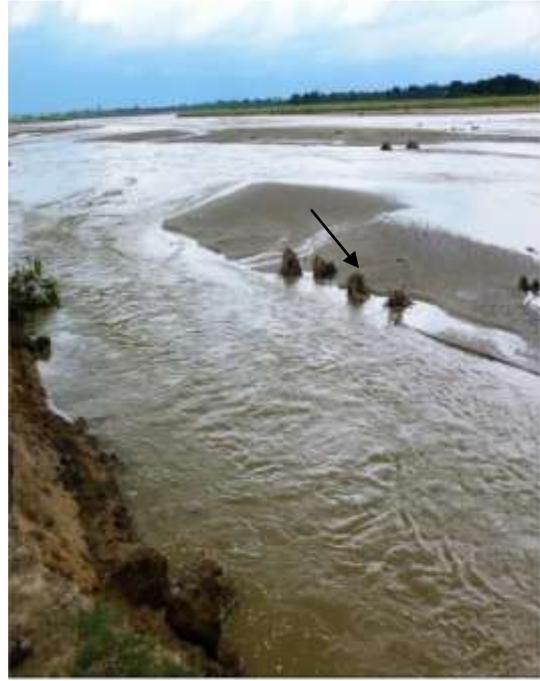
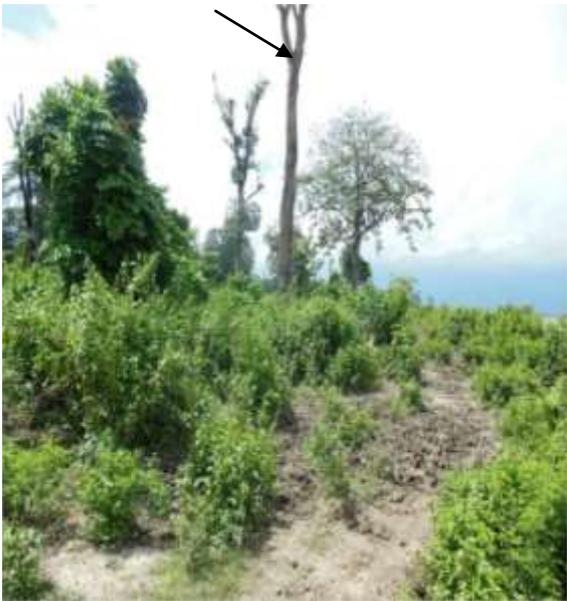
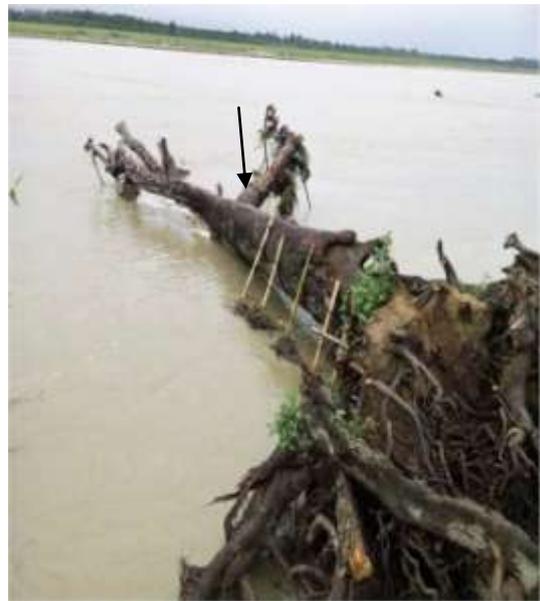
Plate 9.5 (a, b, c & d): Showing Erosion by River Gabru in different years

The socio-economic impact of this type of change is very much significant. Due to the erosion of the agriculture and resident areas the people had to migrate to another places and have to start a new life. They occupy forest land for their livelihood which is causing loss of forest land and fragmentation of the natural habitat. Sedimentation due to River Gelgeli is shown in **Plate 9.2 (a) and (b)** where it can be seen that sands and gravel has been deposited in a vast area. Forest loss due to erosion by River Gelgeli is shown in **Plate 9.3 (a) & (b)** and in River Belseri is shown in **Plate 9.4 (a) & (b)**. Forest loss and bank erosion is shown in **Plate 9.4 (a), (b), (c) & (d)**. It is observed that huge bank erosion is occurring in the bank of River Gabru. The construction of heavy embankment is also not sufficient to control the bank erosion as shown in **Plate 9.5 (a) & (b)**.

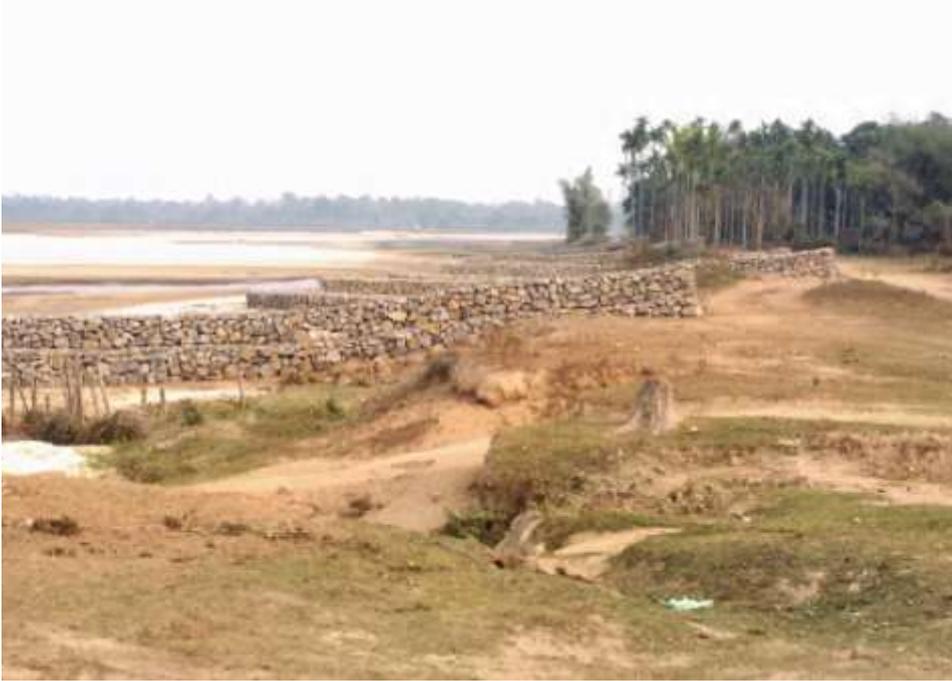
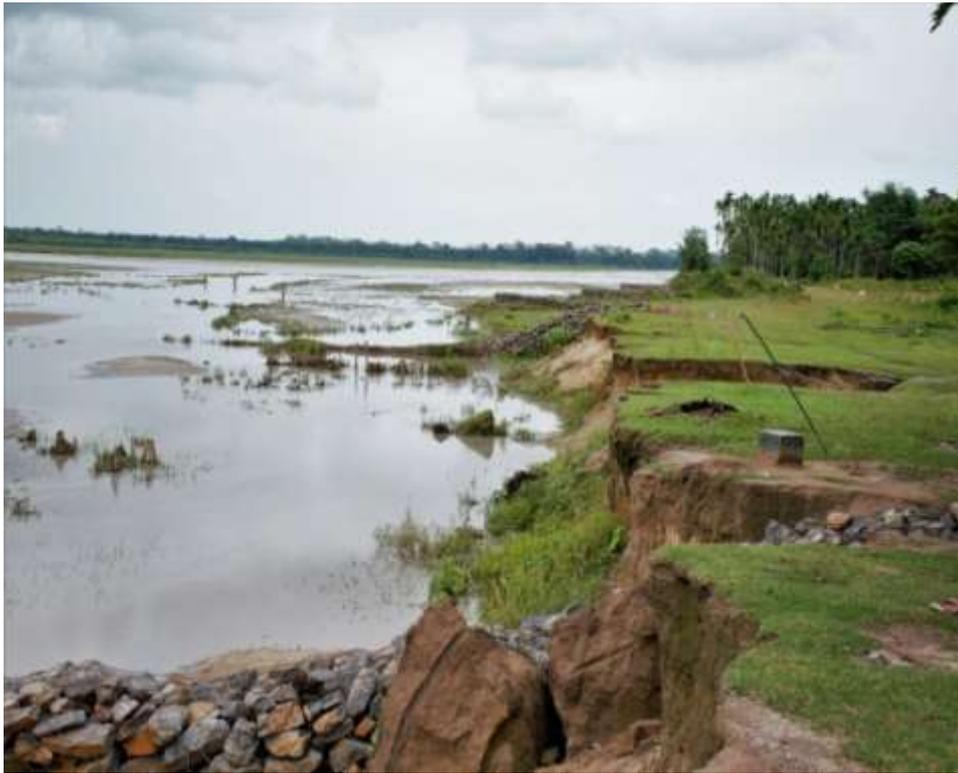
Plate 9.6 (a & b): Showing Bank Erosion by River Gabru
